STUDY AND RECOMMENDATIONS ON THE SAN GERMAN VAULTED
BRICK TUNNEL STORM SEWER SYSTEM

Project No. 5

FINAL TECHNICAL REPORT
TO
U.S. DEPARTMENT OF THE INTERIOR
WASHINGTON, D.C. 20240

July 1988

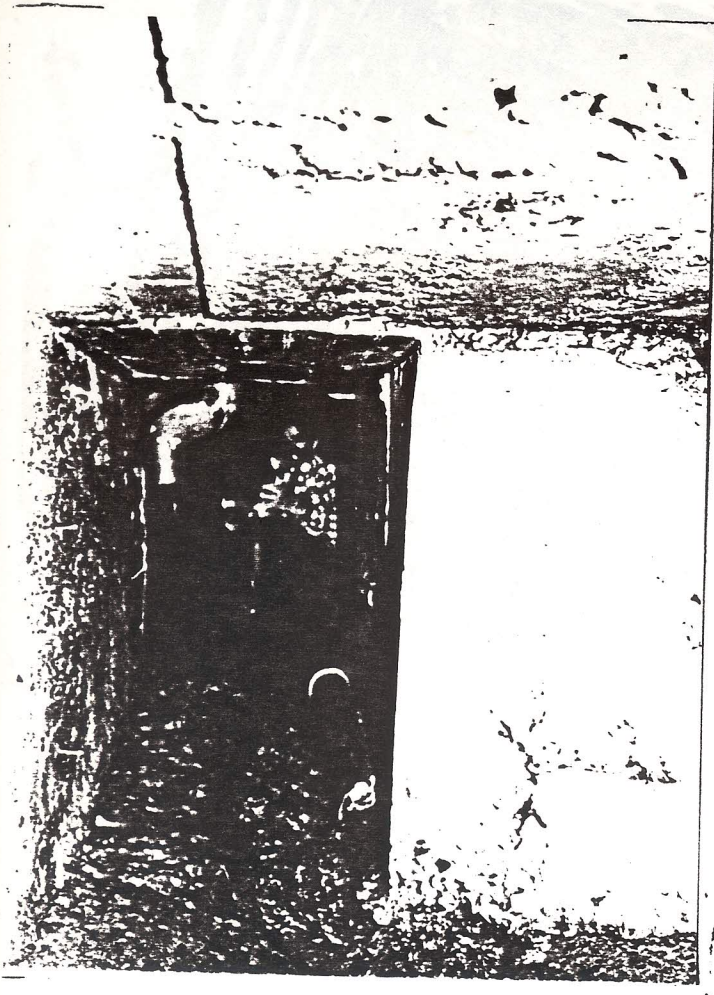
◀ (3)

It can be stated that under the present conditions the tunnel crosssection is sufficient to handle the water flow volume. The flood problems in some streets, and the constriction in crosssection caused by a building column in the upper portion of the tunnel (See Drawing No. 3 and Photo No. 3) are problems that can and should be solved.

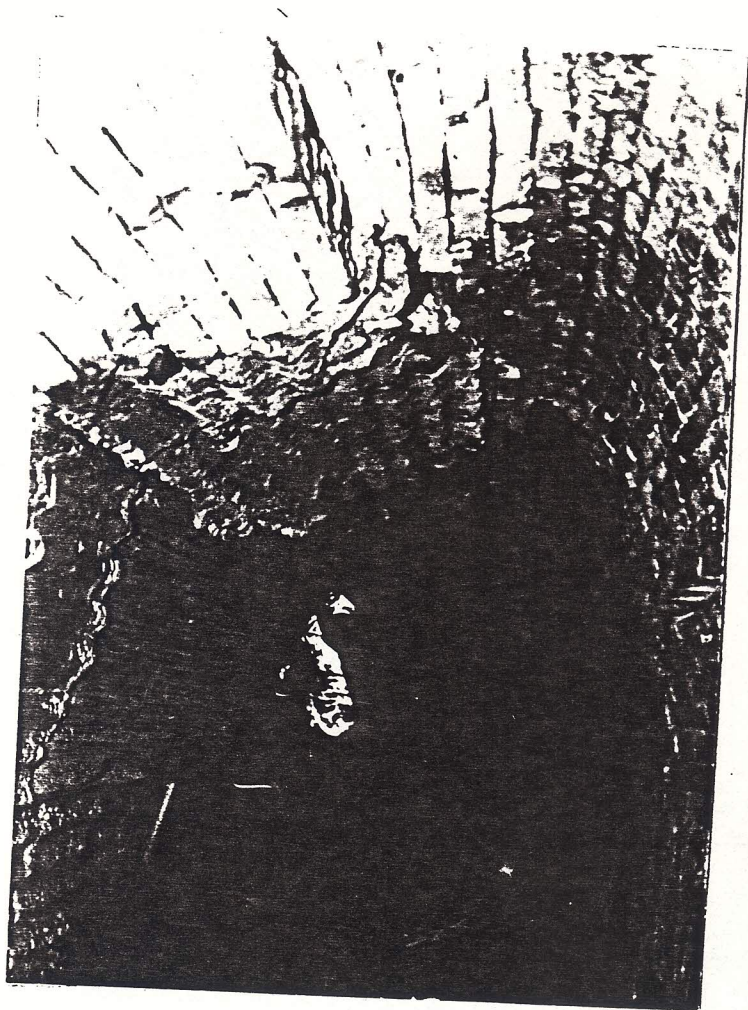
6 ▷

builder involved, probably between 1885 and 1895. The west wall and the vault near the lower end of the section oriented to the northeast shows extensive and unsightly repairwork, done in concrete with corrugated iron sheets (See Photo No. 6).

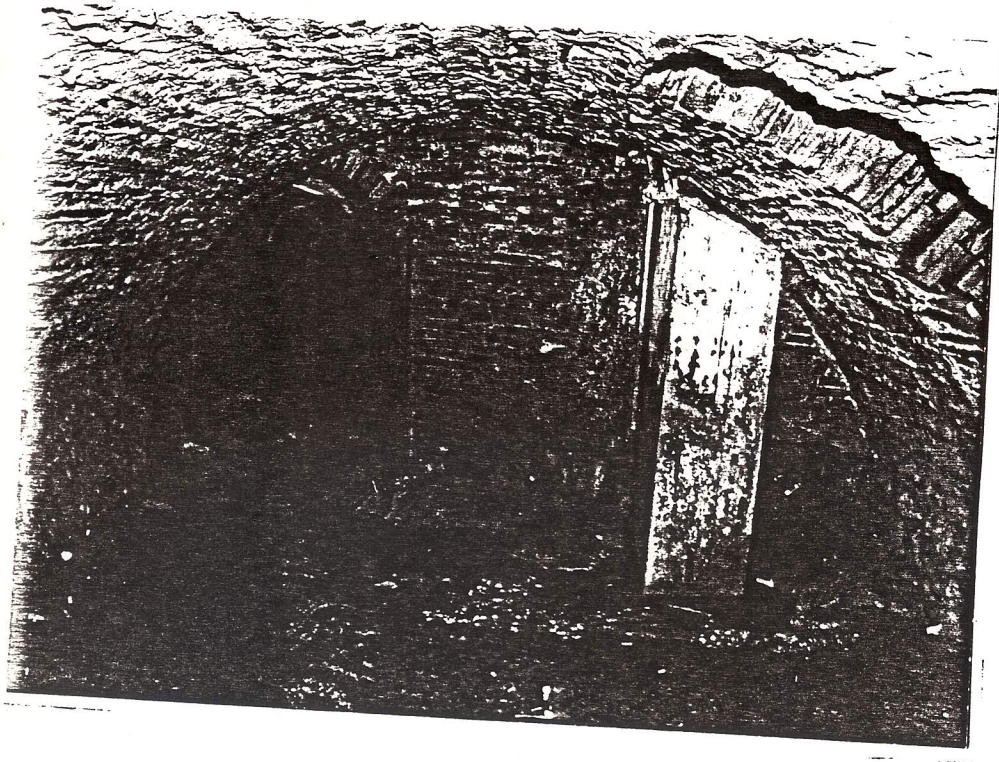
◁ 13

vaulted bridge, which spans 148 inches (See Photo No. 13). Two brick drainage structures discharge storm water from Calle Luna and Calle Cruz into this bridge segment; these must be their original structures built in 1867 (See "Historical Background"). The floor of this chamber-sized bridge section shows extensive damage.

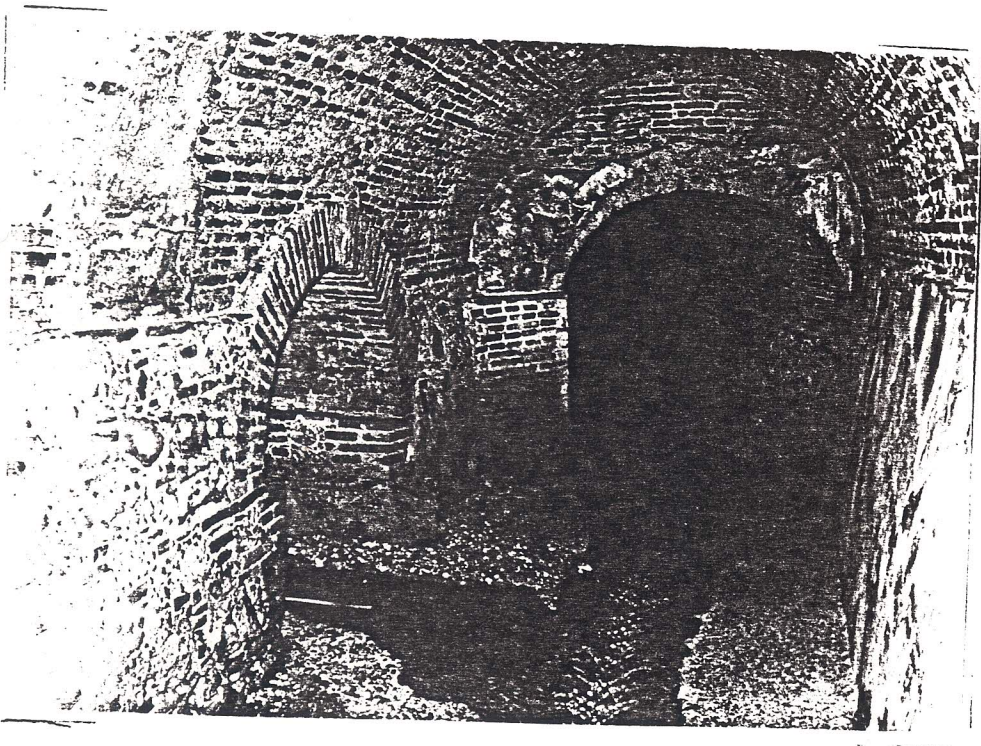
18

A horizontal vaulted brick branch, about 58 inches high, brings the permanent waters of Quebrada Antongiorgi from the south to join those of Quebrada Manzanares within this culvert (See Photo No. 18). This branch, which runs under the west side of Calle Alfonso XII, collapsed about 10 years ago, interrupting traffic for several months. The collapsed length, and the contiguous part crossing under Calle Luna were replaced by a 48-inch diameter concrete pipe. This stream comes down from beyond an old railroad culvert within the Antongiorgi property; it enters a rectangular concrete conduit which conveys it into the c.1860 vaulted brick culvert about 7 feet south of Calle Luna. There is

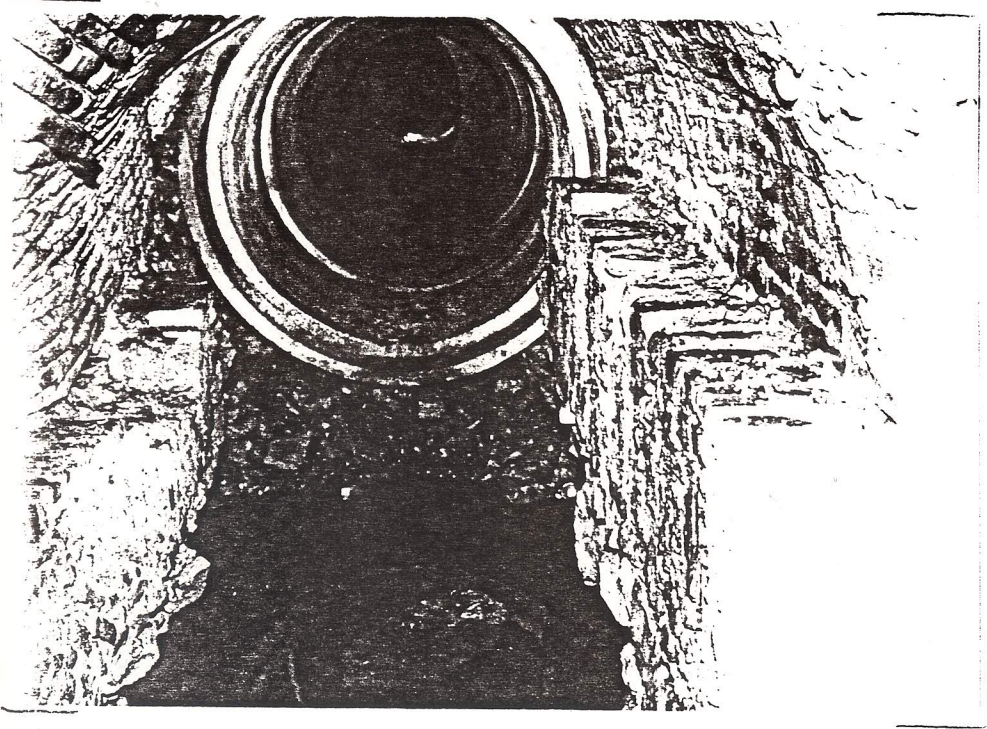
19

extensive, dangerous floor damage in this important branch just beyond the downstream end of the concrete piping (See Photo No. 19). A street drain on the northwest corner of the intersection of Calle Luna and Calle Alfonso XII provides access to this branch and, through it, to the main tunnel.

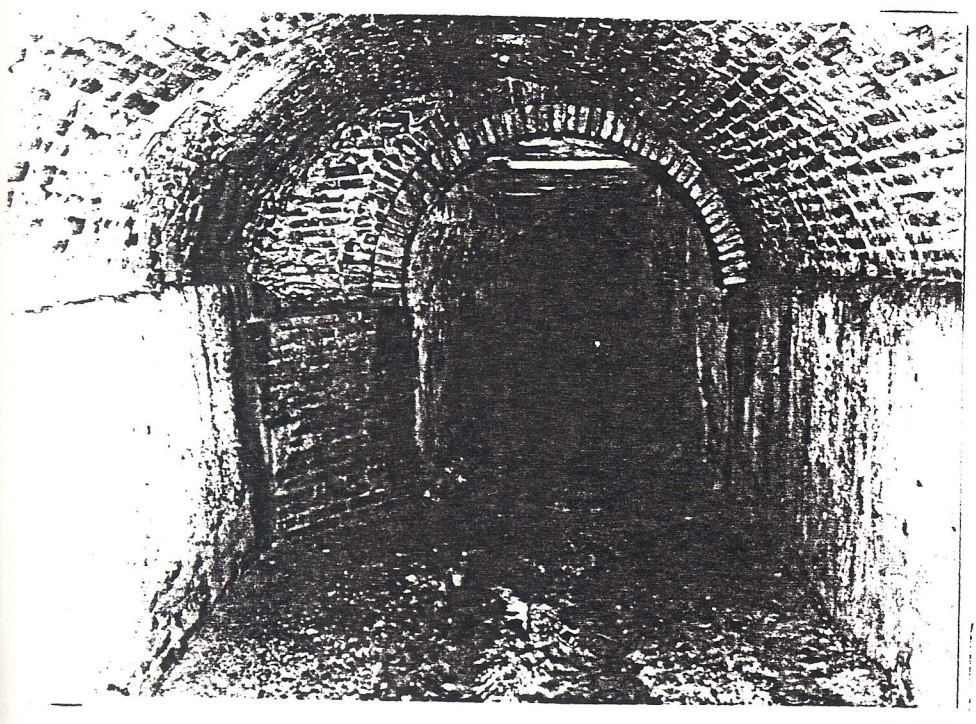
20

At the east end of this culvert, the height of the vaulted roof comes down from 112 to 83 inches. In the tunnel segment beyond, under neath what was the property of Santiago Rivera, the floor slopes down relative to the roof, increasing the vault height to 102 inches at its east end. At this point, the north wall steps in to reduce the tunnel width from 83 to 58 inches. This constriction appears to have been modified by the addition of a headwall to improve flood-flow conditions (See Photo No. 20).

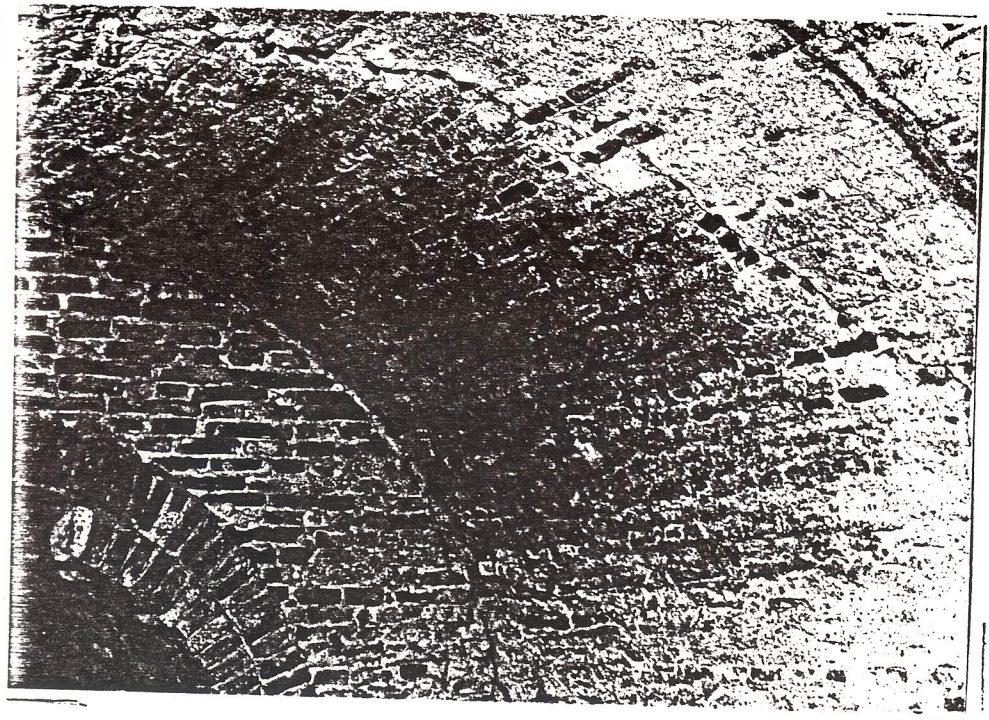
◁ 21

The tunnel again flares out when it becomes the Calle Ramas culvert, a c.1865 structure. This culvert has inclined instead of vertical sidewalls (See Photo No. 22). It is 100 inches high and 88 inches maximum width (at the vault recess). A dangerous crack runs accross the vault near the upstream end of the culvert (See Photo No. 21).
