STUDY AND RECOMMENDATIONS ON THE SAN GERMAN VAULTED
BRICK TUNNEL STORM SEWER SYSTEM

Project No. 5

FINAL TECHNICAL REPORT
TO
U.S. DEPARTMENT OF THE INTERIOR
WASHINGTON, D.C. 20240

July 1988

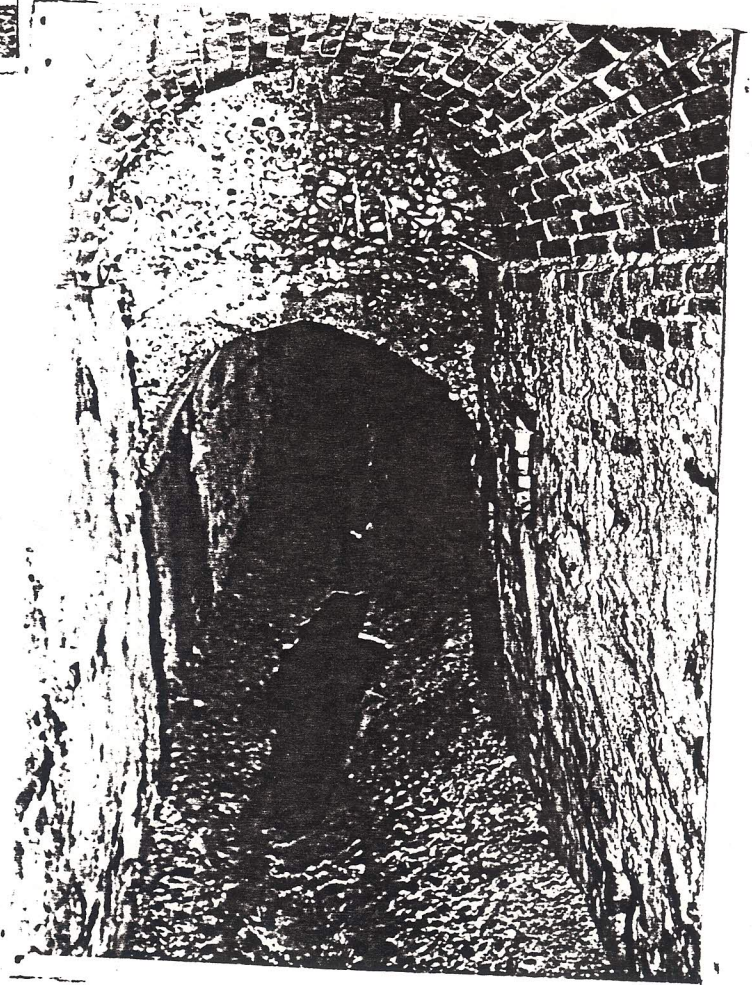
◀ (3)

(See Photo No. 2), which crosses under the property located at the northwest corner of Calle Ferrocarril and Calle Esperanza. The rectangular construction ends at a serious constriction caused by a foundation column which projects halfway into the tunnel (See Photo No. 3). A higher, vaulted section, also in concrete, follows. Upon reaching Calle Central, the Quebrada Manzanares tunnel turns slightly east. The concrete segment under this street, which has a recessed vault, dates from 1911 (See "Historical Background"). So does the vaulted concrete segment to the north which crosses under a block-long property with a c.1911 sculptured concrete block home to reach the Calle Tetuán vaulted brick culvert.

It can be stated that under the present conditions the tunnel crosssection is sufficient to handle the water flow volume. The flood problems in some streets, and the constriction in crosssection caused by a building column in the upper portion of the tunnel (See Drawing No. 3 and Photo No. 3) are problems that can and should be solved.

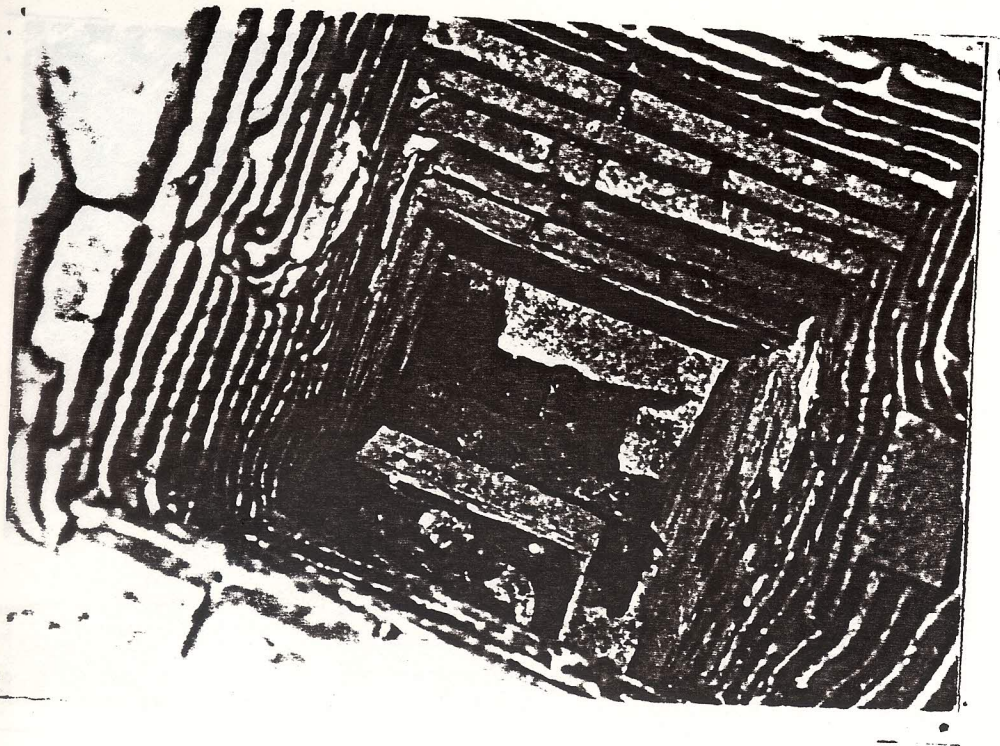
(4) ▶

The Calle Tetuán culvert, made in brick, is older and much taller than the concrete segments which lead down to it (See Photo No. 4).

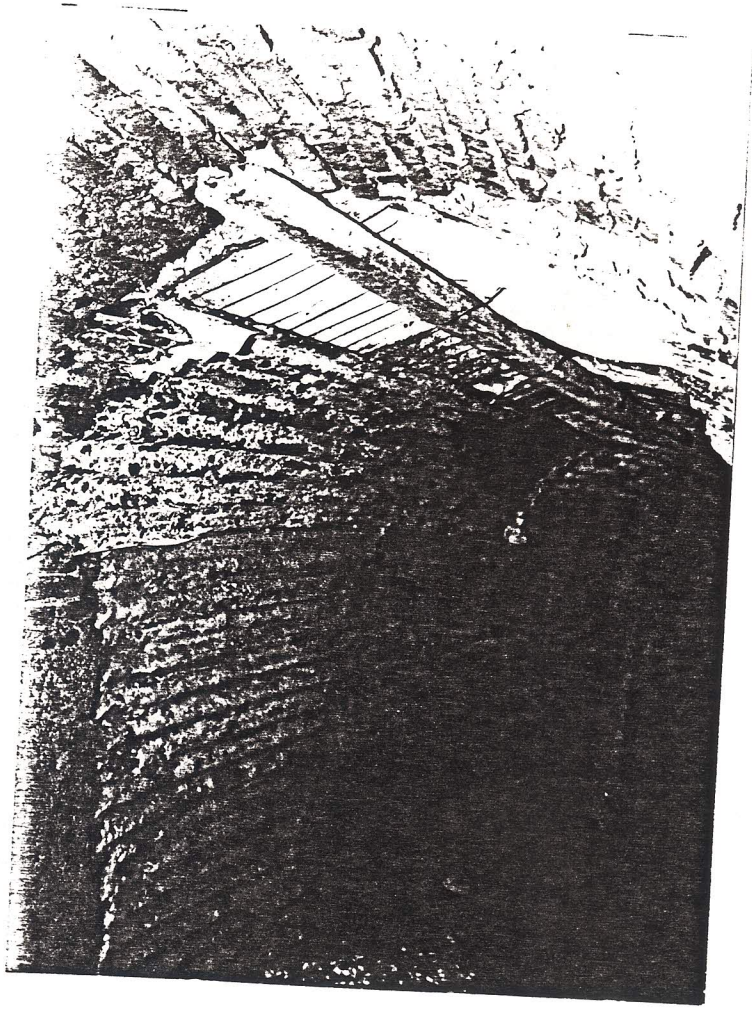
◁ 13

vaulted bridge, which spans 148 inches (See Photo No. 13). Two brick drainage structures discharge storm water from Calle Luna and Calle Cruz into this bridge segment; these must be their original structures built in 1867 (See "Historical Background"). The floor of this chamber-sized bridge section shows extensive damage.
